**US Army Corps
of Engineers**

USACERL Special Report 99/01
October 1998

Shear Strengthening of Reinforced Concrete Beams Using Fiber-Reinforced Polymer Wraps

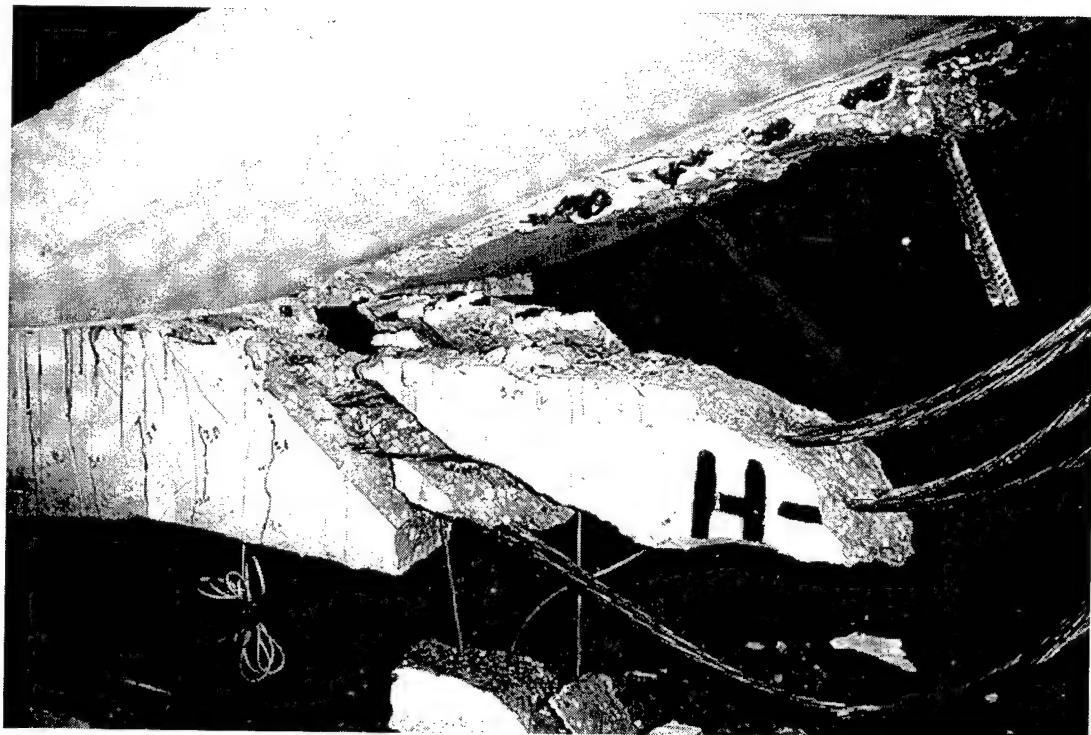
None of the joists cracked when the prestressing tendons were released. During handling, specimen HJ-7 developed a crack across the slab through its depth near the south strut. Cracks were marked on each of the joists throughout testing. Cracking and failure mechanisms resulting from testing of HJ-6 and HJ-7 were compared with those of the two hybrid joists upgraded or repaired with FRP. Early in the test series, limited cracking occurred in the bottom chord of HJ-6. As actuator stroke was increased, cracking in the shear spans became evident but the cracks in the bottom chord did not develop further. In HJ-6 an inclined crack developed near the support and progressed upward along the web/slab interface (Figure 35). This crack progressed into the slab and failure ultimately occurred in this North end of the joist (Figure 36).

Figure 36. Failure of HJ-6.
